PULPAL CURETTAGE, A CONSERVATIVE TECHNIQUE

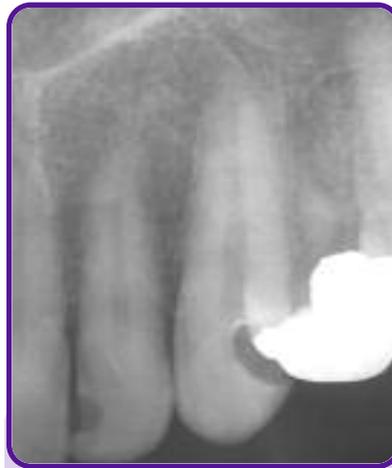
Figure M1
Shows dentin bridge eighteen years following pulpal curettage.

This case goes back to 1962, and at the time I placed a restoration of self-curing resin. In 1980 I decided to replace the restoration using modern materials. I cleaned out the old self-curing resin and took a radiograph that shows the "new" dentin bridge formation at the amputation site (*M1*).

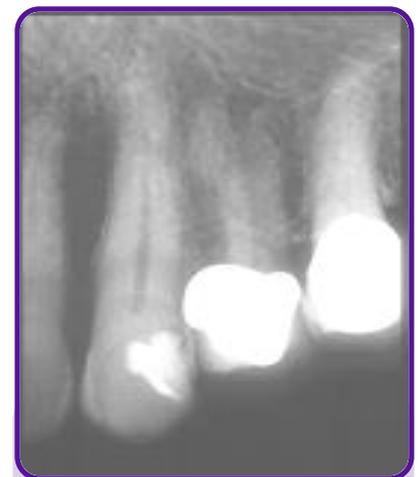
Figure M2
Mace's cuspid thirty-eight years following pulpal curettage.

How lucky can a dentist get! Mace came to my office on election day, November 7, 2000. He was having slight discomfort on his left side, so he came into town to have his teeth checked. I examined him clinically and reviewed the radiographs that he brought me from his periodontist, but I was unable to identify a problem. I told Mace that his case was going to be in my book, and I asked if I could take another radiograph of his maxillary right cuspid. *Figure M2* is the radiograph taken thirty-eight years and one day following pulpal curettage. Note the density of the dentin bridge and the still patent root canal.
